**SUBJECT:** An equipment operator died after being run over by a double trailer truck.

**SUMMARY**  
**California FACE Report #03CA009**

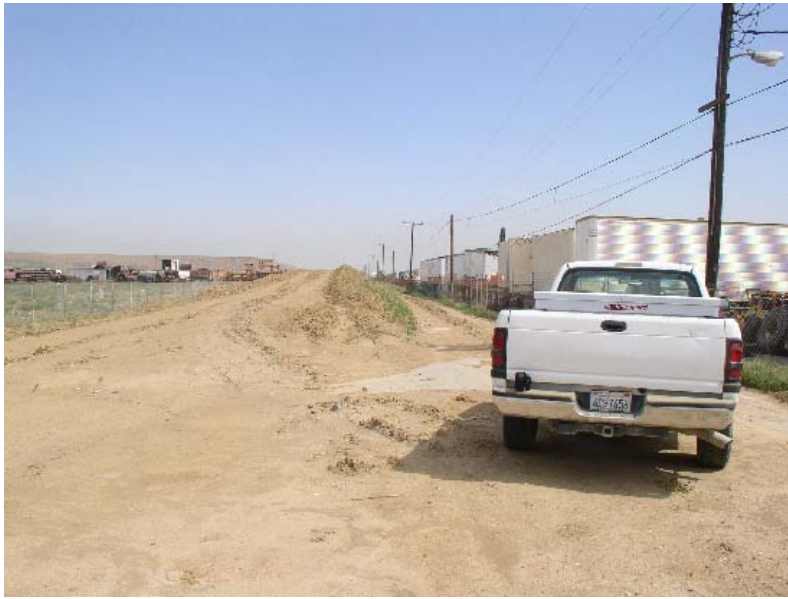
Exhibit #1

The above picture is the asphalt road where the incident occurred, looking west. The dirt clay mixture was stored on the road, and then removed as needed for land fill at an adjacent dump. The rear of the pickup truck marks the approximate stop where the victim was standing when struck by the rear tires of the bottom-dump trailer.

The site of the incident was an asphalt road that was being used as a temporary storage site for a mixture of dirt and clay that was to be used later at an adjacent garbage dump site. The dirt was being dumped on one side of the road in the shape of a berm that measured approximately four feet high at the time of the incident (**Exhibit #1**). The bottom-dump trucks would drive on top of the dirt berm, dump their loads, and then head back along the other side of the road to get another load. The grader, driven by the victim, would level off the dirt so the trucks could continue to drive on it.

On the day of the incident, the victim was assigned to operate the grader and level out the dirt the trucks were dumping on the top of the berm. A truck pulling two bottom-dump trailers dumped his last trailer, and then proceeded off the berm at the end of the berm where the grader was parked. The victim was standing on the ground near the grader. The truck then proceeded to make a left-handed U-turn. Halfway through the U-turn, the driver of the truck stopped. The victim walked up to the driver's door and told the driver to circle back and dump the other trailer behind the load he just dumped. The victim then stepped away from the truck. After the truck driver saw the victim step away from the truck, he completed his U-turn, and then drove back alongside the berm. The victim was struck by the left-side tires of the last trailer. The truck driver was unaware of the collision until he was flagged down by another driver. The paramedics were called, and the victim was transported to a hospital where he was pronounced dead.

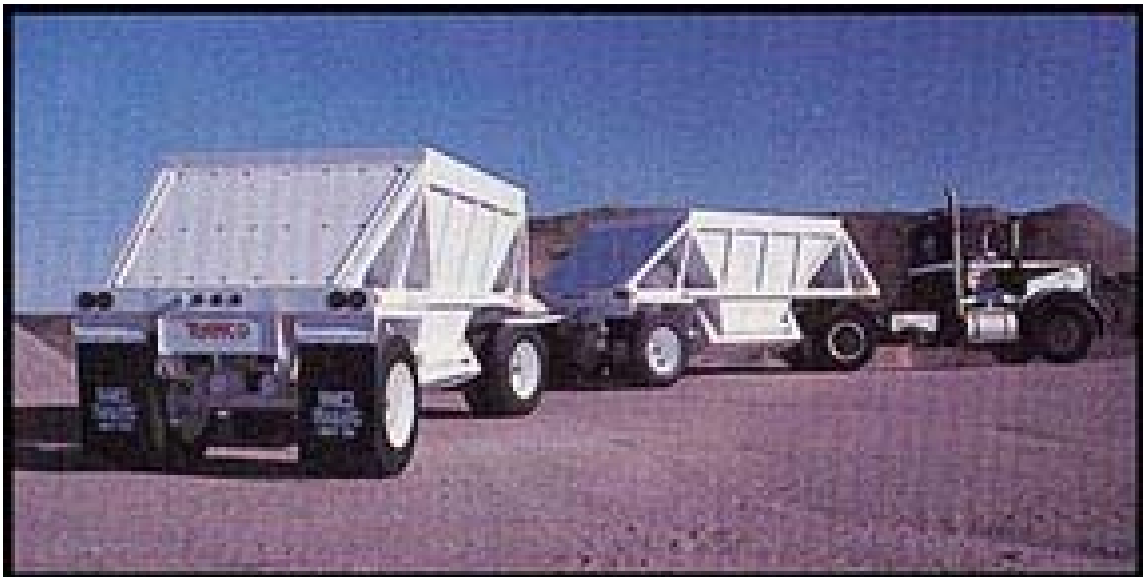
Exhibit #2

A picture of a bottom-dump trailer similar to the one involved in the incident.

The vehicle involved in this incident was a tractor with two trailers (**Exhibit #2**). The tractor was a cab-over, two-axle with a gross vehicle weight (GVW) of 32,000 pounds. The first trailer was a bottom-dump, single-axle with a GVW of 35,000 pounds. The second trailer was a bottom-dump, two-axle, with a GVW of 40,000 pounds.

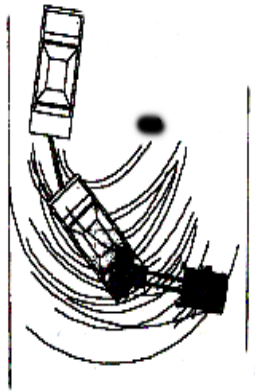
Exhibit #3

This drawing depicts the path of the tires on the tractor and trailers when in a U-turn. The oval shows the approximate spot where the victim was standing when struck by the left rear tires of the last trailer.

In this incident, the rear wheels of the truck followed a very different path than the front wheels. The path of the rear wheels followed a much smaller "radius." This is known as off-tracking. This off-tracking makes it possible for objects that are at a considerable distance from the front of the truck to be hit by the rear of the truck during turns (**Exhibit #3**). The truck driver completed his turn while the victim was still in the area where he could be hit. The driver stated

that he never felt or heard anything unusual after he completed his U-turn. He accelerated from the incident scene without even knowing he had run over the victim. Had the driver waited until the victim was completely clear of the trucks path before moving, this incident might have been prevented. Employers can ensure worker compliance with safe work practices through continued documented programs of training, supervision, safe work recognition, and progressive disciplinary measures.
